RAWFILL WP I1
Desk study
Archives and inventory report

June 2017

OVAM

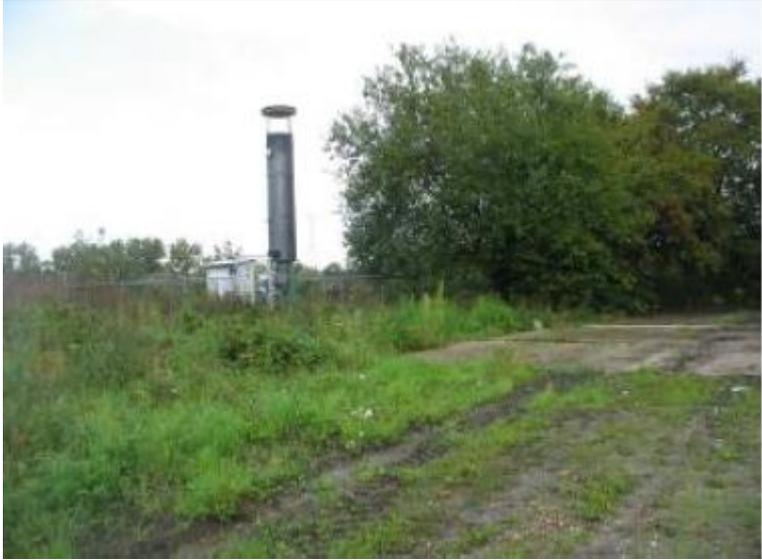
<p>View on the gas extraction installation (lower part)</p>

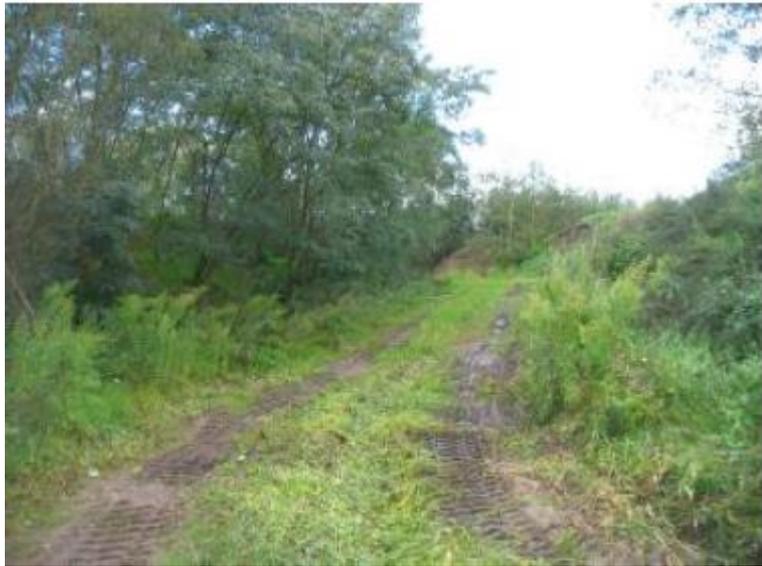
<p>Path between the lower and higher part of the landfill.</p> <p>The eastern part of the site is now a waste sorting facility. This is the only entrance to the landfill and is only open during working hours (ca. 8h-16h) and on demand.</p>
<p>OVAM file number</p>	<p>The reference number is 12290. This is an OBO (orientating soil investigation) number. Two investigations were done : in 2000 and 2004.</p>

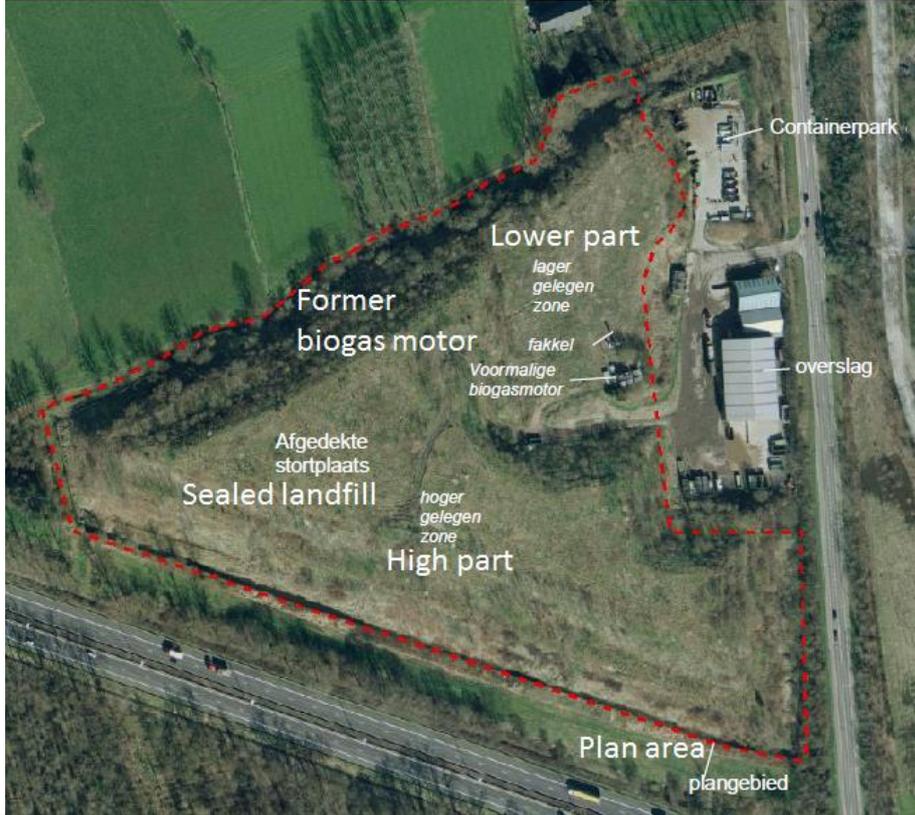
<p>Sections of the landfill</p>

<p>Thickness of the landfill</p>	<p>The landfill of Meerhout is completely built on the original ground level, therefore the thickness of the waste is the same as the current prominence of 10 and 20 metres respectively.</p>
<p>Topography</p>	<p>The landfill area can be divided into two main areas : the northeastern level of about 10 metres which is the oldest part of the landfill (sixties) and not sealed with HPDE foil. The southern, highest part (20 metres) is the most recent extension dating from the eighties and is sealed properly.</p>
